ITEM FOR ZONING AND PLATTING COMMISSION

**ADDRESS
OF PROPERTY:** 4709 Highland Terrace

SUBJECT: 4709 Highland Terrace

REQUEST: Retroactive variance from LDC 25-8-641 – Impacts to three Heritage Trees.

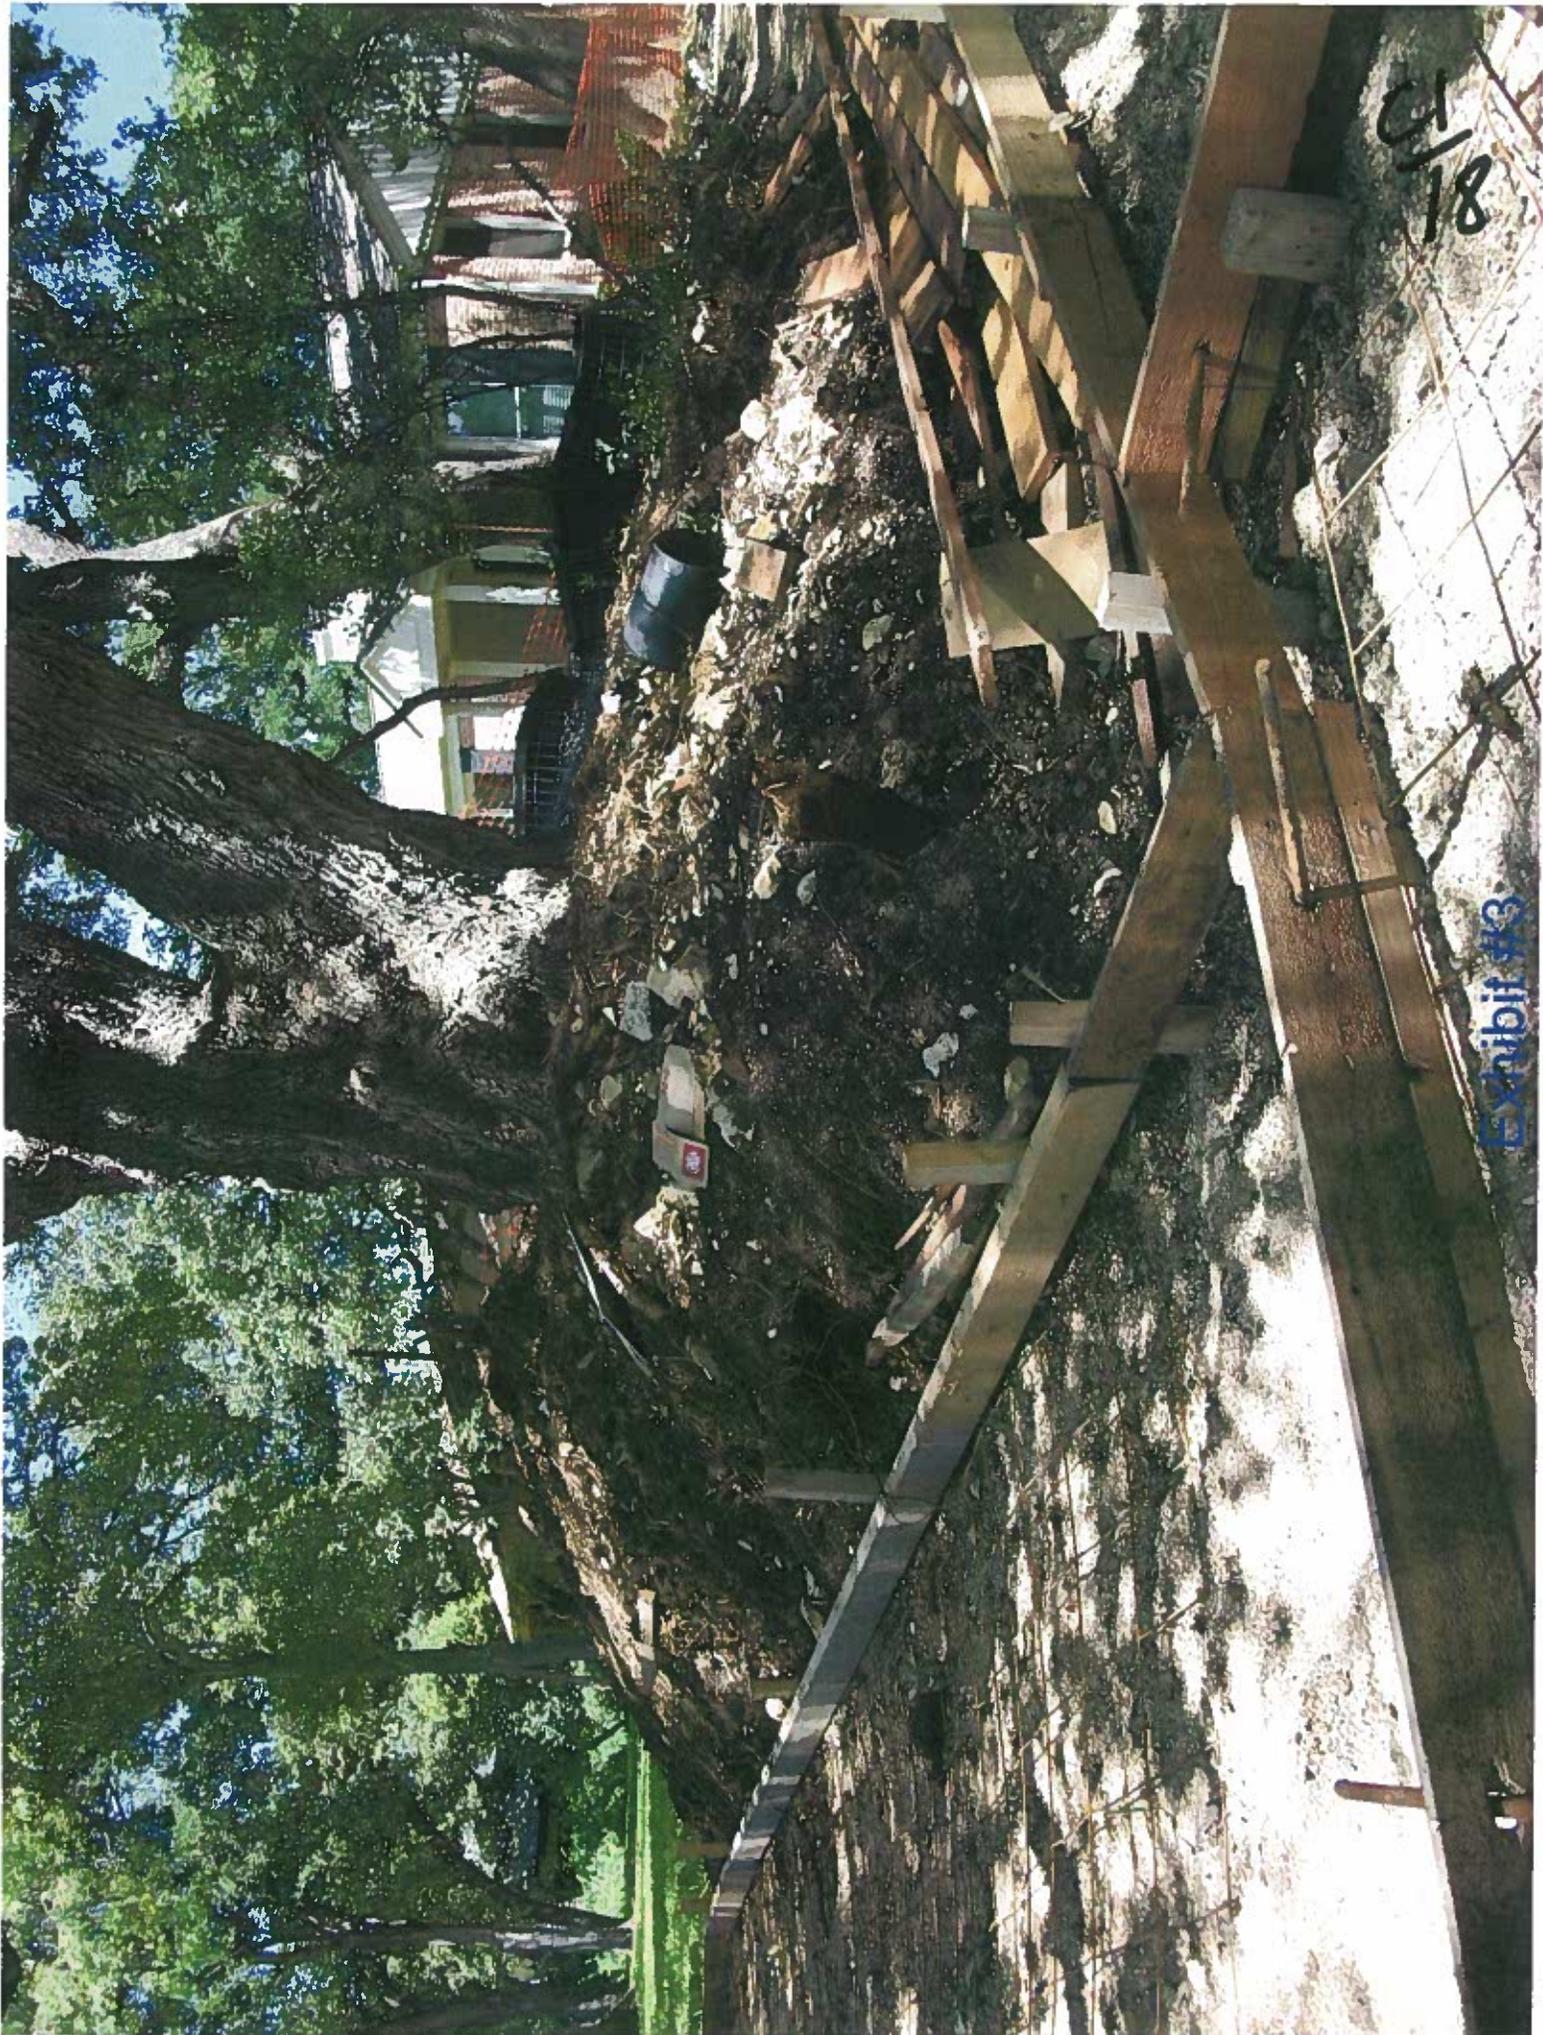
Exhibit #3

the TORA and, thus, was closer to the 40" Live Oak (Tree #1) than what had been approved (Exhibit 3). The noncompliant shifting of the driveway also resulted in further encroachment into the critical root zones of the neighboring 26" (Tree #2) and 36" (Tree #3) Live Oak trees at 4711 Highland Terrace (Exhibit 4). Further violation occurred with temporary fill material, debris, and a temporary bathroom facility were all located within the ½ critical root zones of two 19" Cedar Elms (Trees # 4 and 5) (*Ulmus crassifolia*) and a two stem 30"x19" Live Oak (Tree #6). An additional violation was the absence of tree protection fencing for the 40" (Tree #1) Live Oak. Of the six trees impacted by construction activities, the 40" Live Oak (Tree #1) on the subject site and the 26" (Tree #2) and 36" (Tree #3) on the neighboring property were impacted beyond what code allows. The 40" Live Oak (Tree #1) sustained extensive root damage and removal of root mass while the 26" (Tree #2) and 36" Live Oaks (Tree #3) sustained minimal impact from approximately 2.5" of cut into the critical root in preparation for forming the driveway.

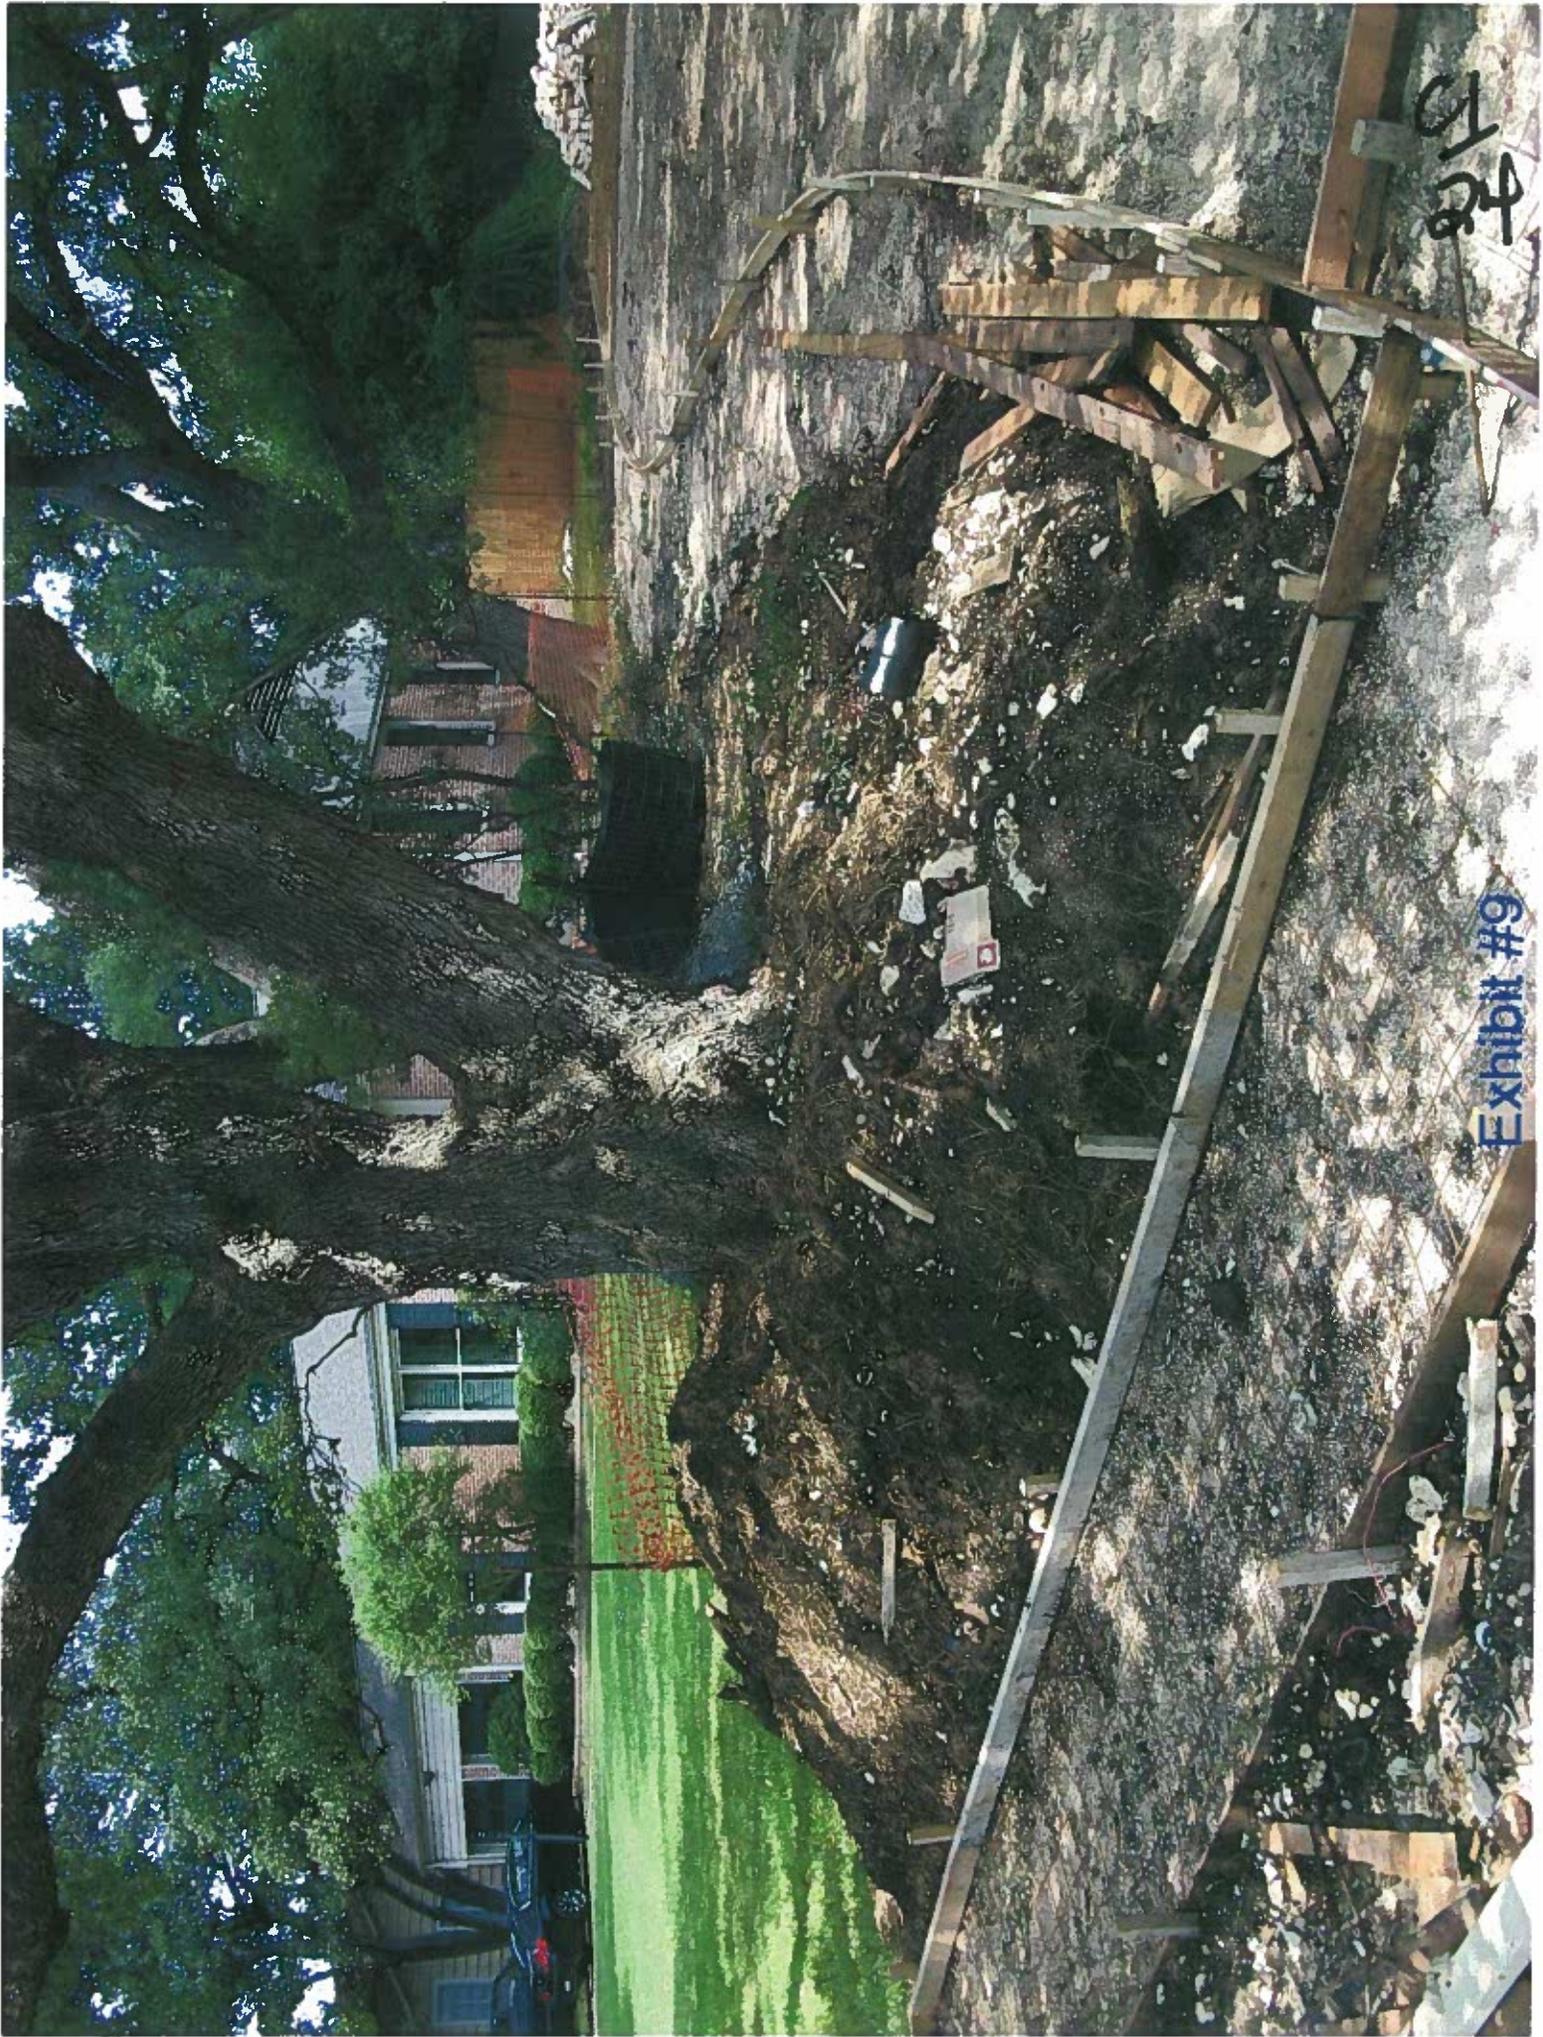
Exhibit #9

The initial site assessment after the impacts occurred revealed extensive damage to root structure and reduction of root mass (Exhibit 9). Cutting and forming-up the sidewalk

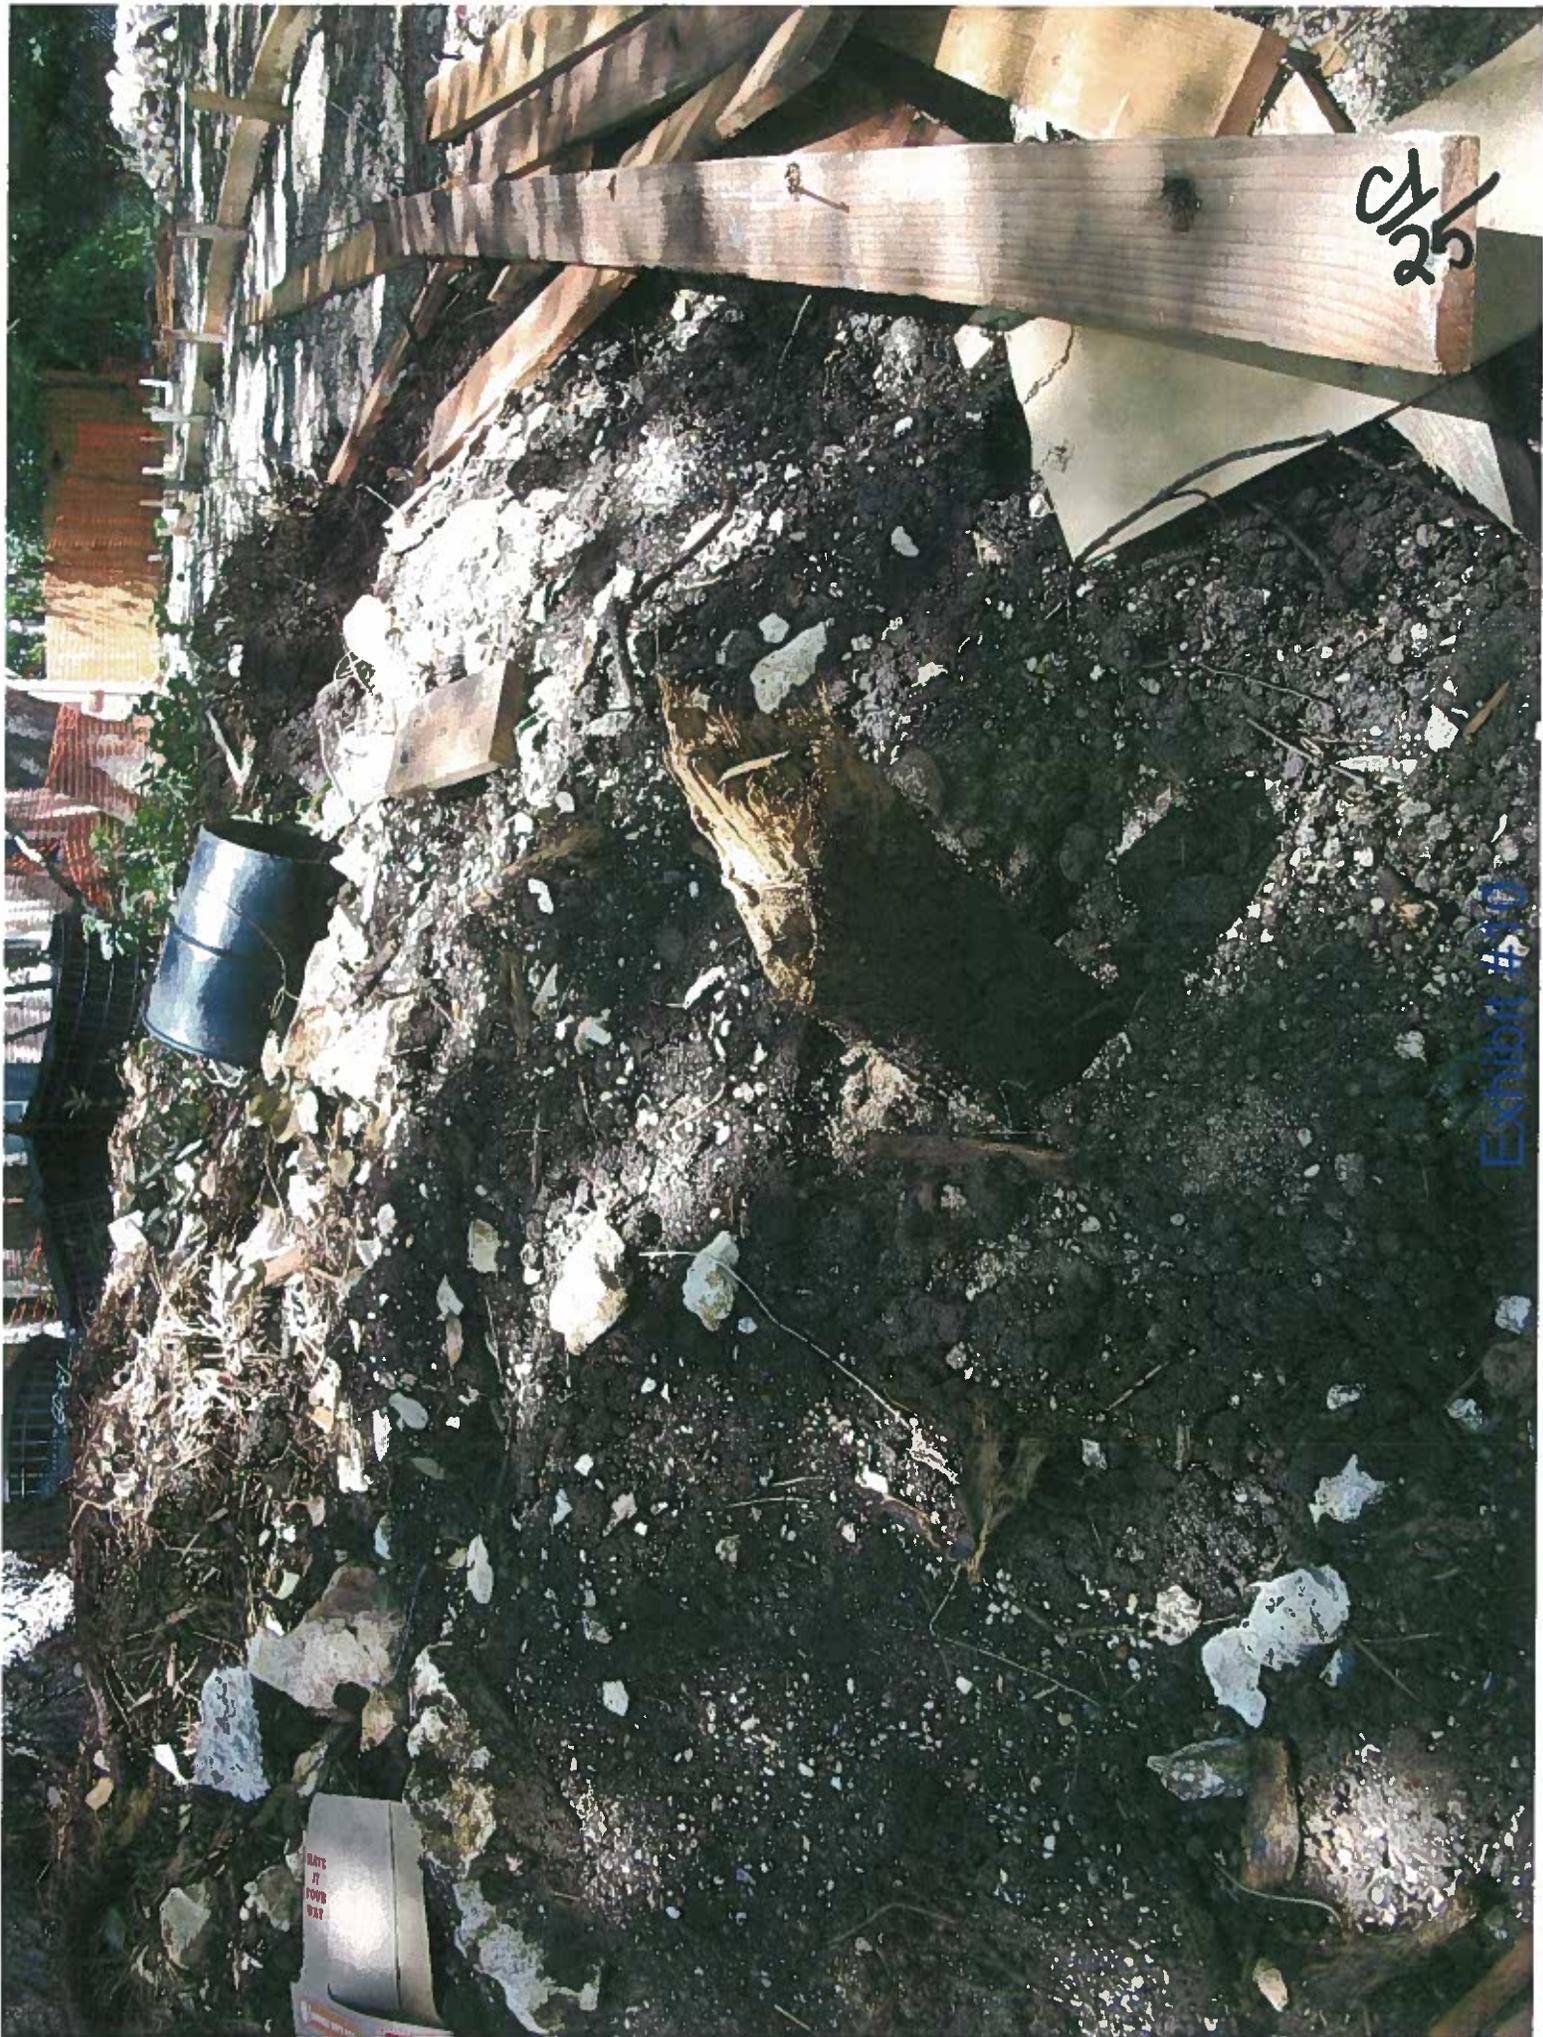
Exhibit 410

had resulted in encroachments within three feet of the subject tree. Further, approximately 2.5' of fill material had been placed around the root collar of the subject tree. It was also apparent that machinery had severed 3-6" diameter anchoring roots (Exhibit 10). The severed roots had also been ripped rather than cut resulting in further subsurface damage. Additional damage and removal to root structure resulted from shifting the driveway closer to the subject tree in violation of the approved tree permit that stated that only the existing driveway location could be reused. Regarding the aerial parts of the subject tree, there appeared to be no bark or vascular tissue damage and the crown appeared to have not been impacted. Extensive root damage has occurred to the subject tree resulting in a high degree of uncertainty if the subject tree can recover.

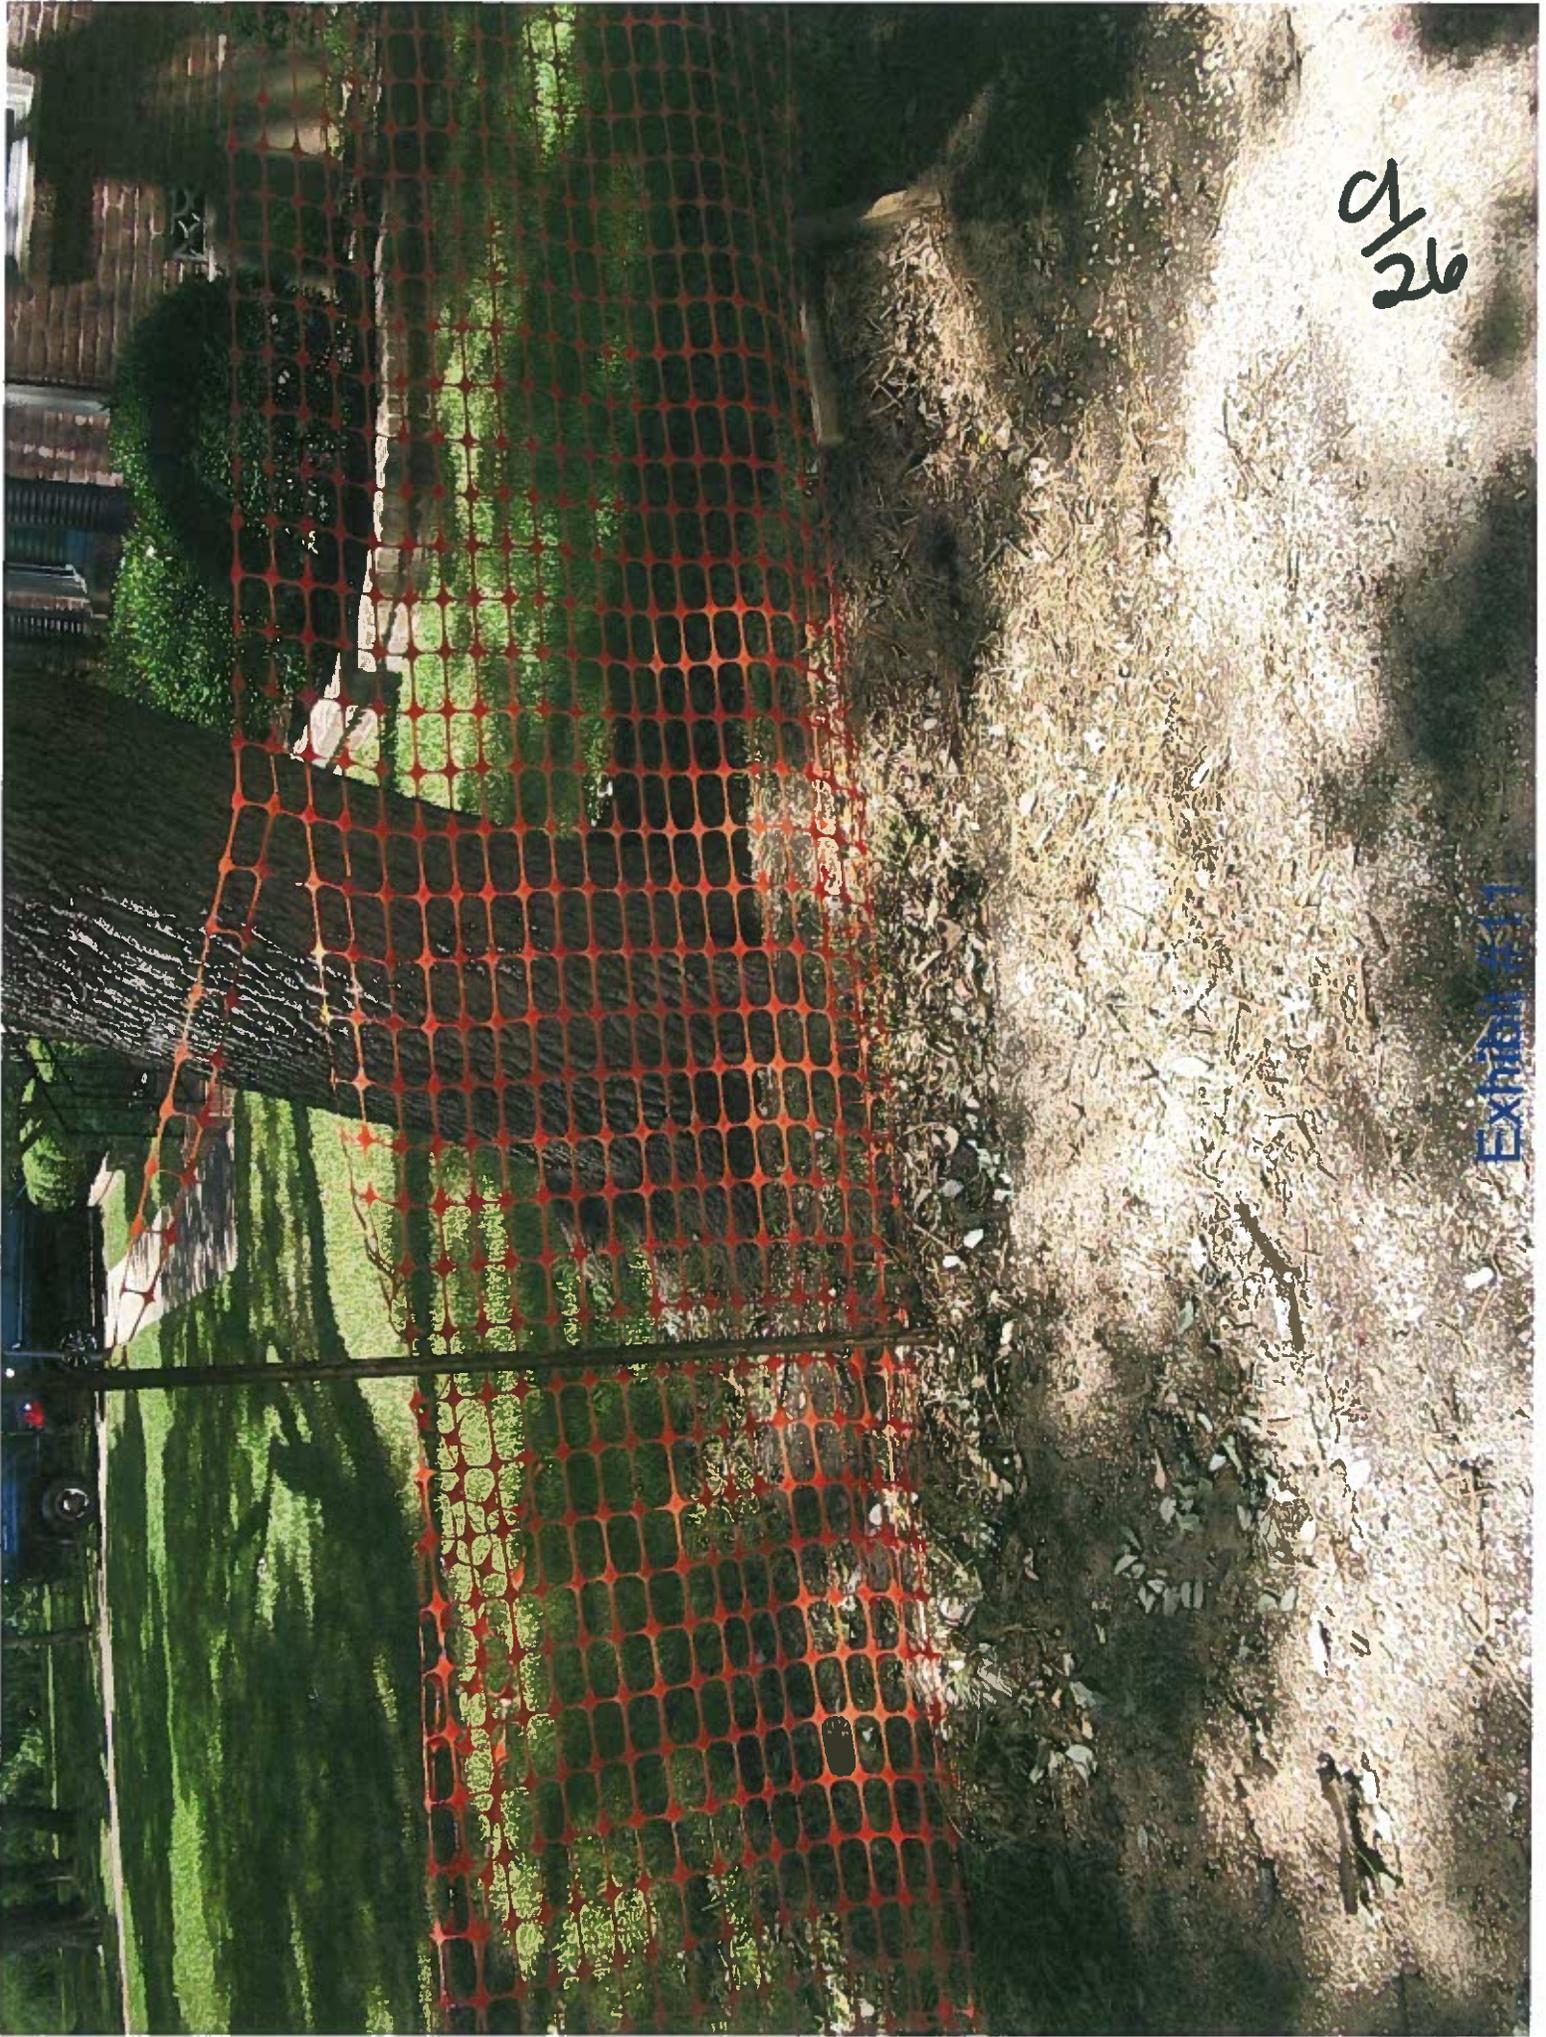
Exhibit #11

The subject trees sustained 1/2 critical root zone impacts from the shifting of the driveway location to the property line (Exhibits 11 and 12). It appears the existing turf grass had been scraped approximately 2.5" in preparation for shifting the driveway to a location that was in violation of the November 13, 2009, tree permit. Root damage to the subject trees was minimal. Only small diameter (0.125"-0.250") roots were disturbed. Regarding the aerial parts of the subject tree, there appeared to be no bark or vascular tissue damage and the crown appeared to have not been impacted. Minimal root impacts occurred to the subject trees. Thus, there is a high degree of certainty the trees can recover from the impacts.
